Asbestos and Hazardous Materials Reinspection Assessment

Broken Bay Sport and Recreation Centre

25/01/2023

754-SYDEN311850 - Broken Bay Sport and Recreation Centre - HMRR - 17012023

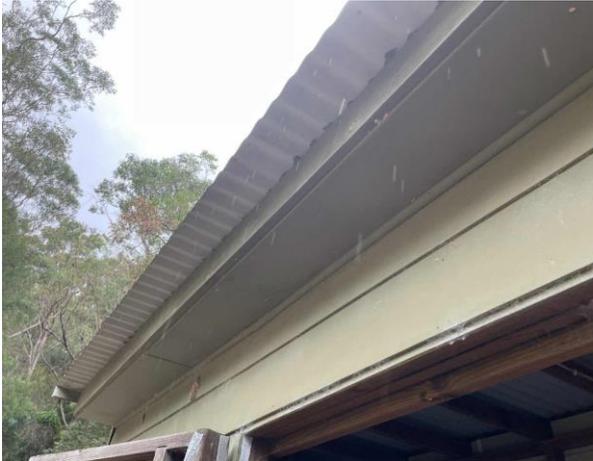
Line ID 1: External, Chemicals Storage Shed, Ground Floor, Eaves to Entrance Side of Shed, Compressed Cement Sheetting - No Asbestos Detected

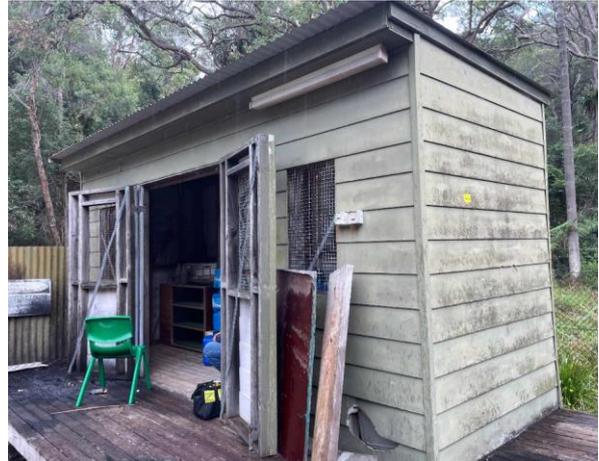
Line ID 2: External, Chemicals Storage Shed, Ground Floor, Walls, Weatherboard Cladding, Compressed Cement Sheetting - No Asbestos Detected

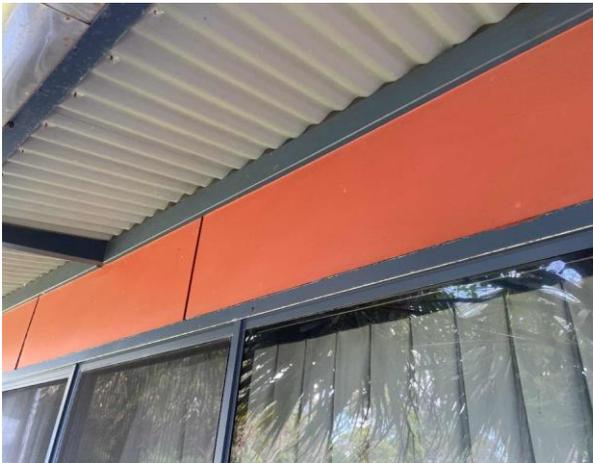
Line ID 3: External, Holiday Units 1-4, Ground Floor, Fascia Panels, Fibre Cement Sheetting - No Asbestos Detected

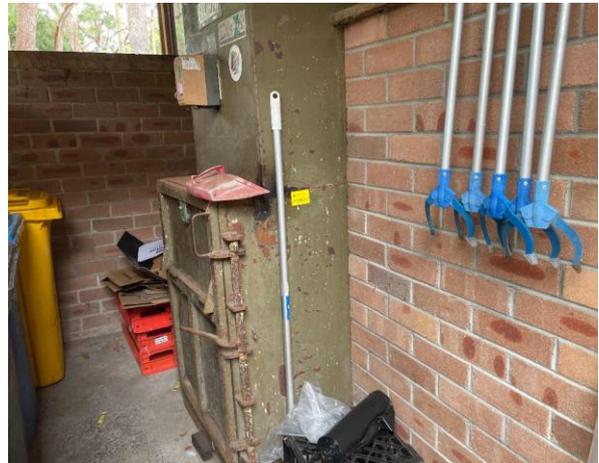
Line ID 4: External, Office Building, Ground Floor, Rope Lining to Baler, Woven Material - Suspected Asbestos

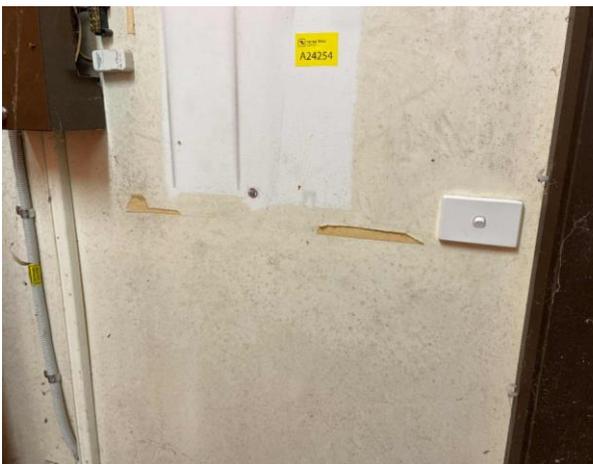
External	Office Building / Ground Floor / Switchboard Room, Wall Lining	Fibre Cement Sheeting	Asbestos	A24254	Chrysotile Asbestos Detected	Non-Friable	20 m ²	Low	5 Yearly Reinspection	Maintain in current condition if to remain in-situ. Remove under controlled non-friable asbestos removal conditions prior to refurbishment or demolition works by a Class B (non-friable) licensed asbestos removal contractor in accordance with relevant State	5

Line ID 5: External, Office Building, Ground Floor, Switchboard Room, Wall Lining, Fibre Cement Sheetting - Chrysotile Asbestos Detected

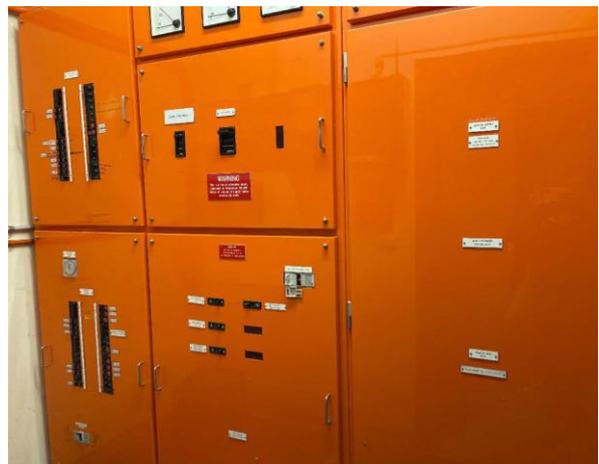
Line ID 6: External, Office Building, Ground Floor, Within Office, Main Switchboard and Redundant Fuses, HRC Fuses - Suspected Asbestos

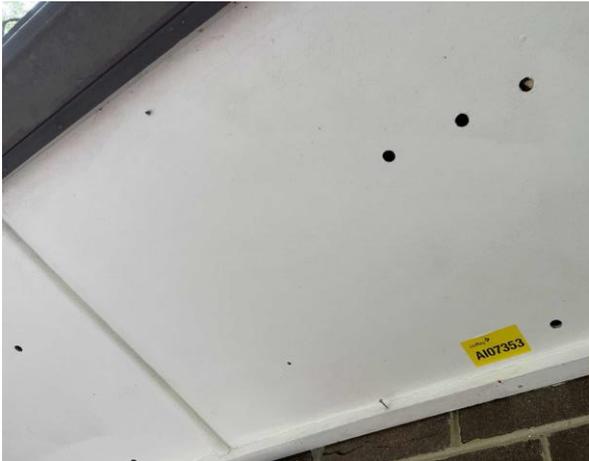
Line ID 7: External, Private Residence, Ground Level, Eaves, Fibre Cement Sheetting - Chrysotile and Amosite Asbestos Detected

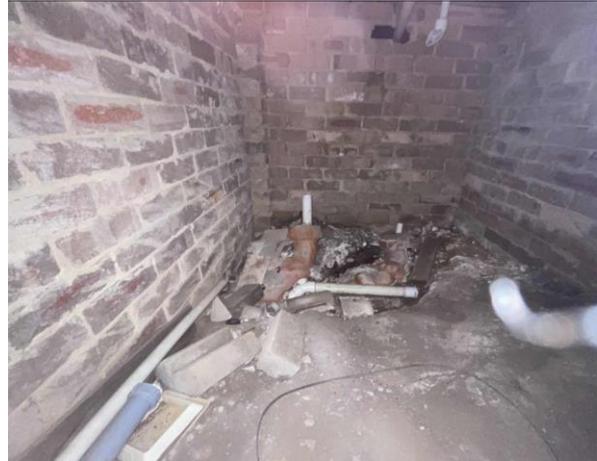
External	Private Residence / Ground Level / Subfloor, Debris Throughout	Fibre Cement Sheet	Asbestos	A24251.1	Chrysotile Asbestos Detected	Non-Friable	2 m ²	Low	As soon as reasonably practicable	Remove under controlled non-friable asbestos removal conditions prior to refurbishment or demolition works by a Class B (non-friable) licensed asbestos removal contractor in accordance with relevant State Regulations, Compliance Codes, Codes of Practice and Guidance Notes.	8
External	Private Residence / Ground Level / Subfloor, Layered on Concrete	Hessian Backed Paper Material	Asbestos	A24255	No Asbestos Detected	-	30 m ²	-	-	-	9

Line ID 8: External, Private Residence, Ground Level, Subfloor, Debris Throughout, Fibre Cement Sheet - Chrysotile Asbestos Detected

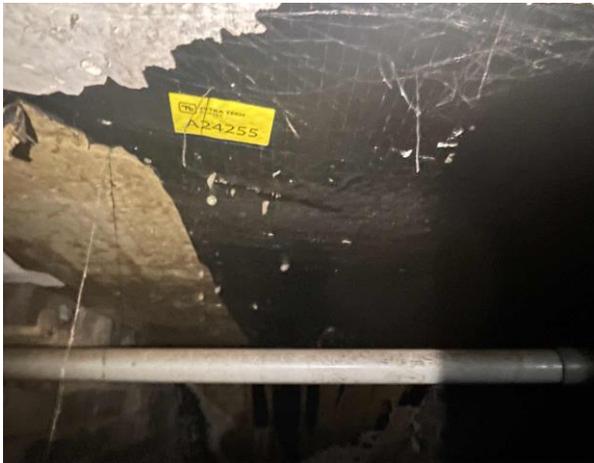
Line ID 9: External, Private Residence, Ground Level, Subfloor, Layered on Concrete, Hessian Backed Paper Material - No Asbestos Detected

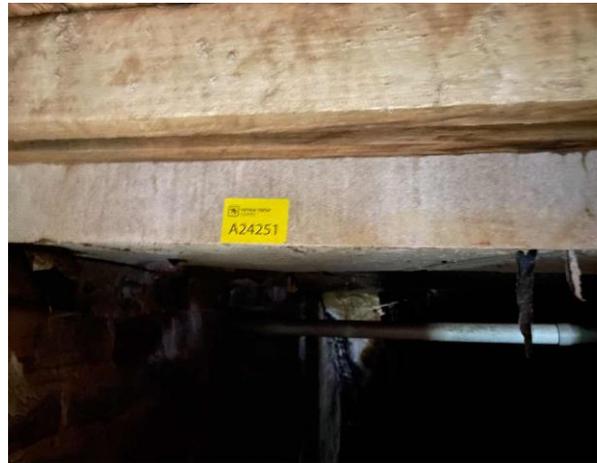
Line ID 10: External, Private Residence, Ground Level, Within Subfloor, Packing Material Under Stairwell, Fibre Cement Sheet - Chrysotile Asbestos Detected

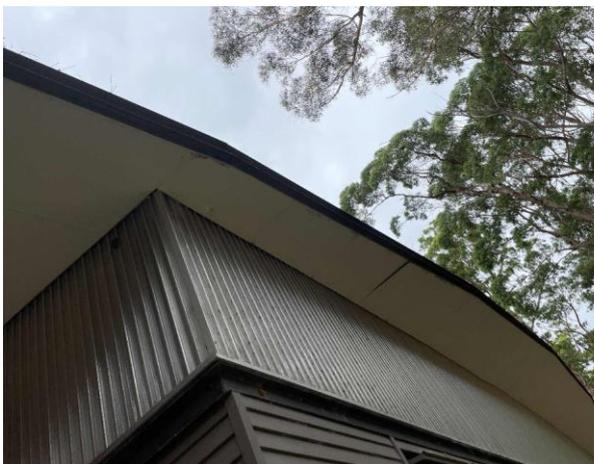
Line ID 11: External, Recreation Hall, Ground Floor, Eaves, Fibre Cement Sheetting - Suspected Asbestos

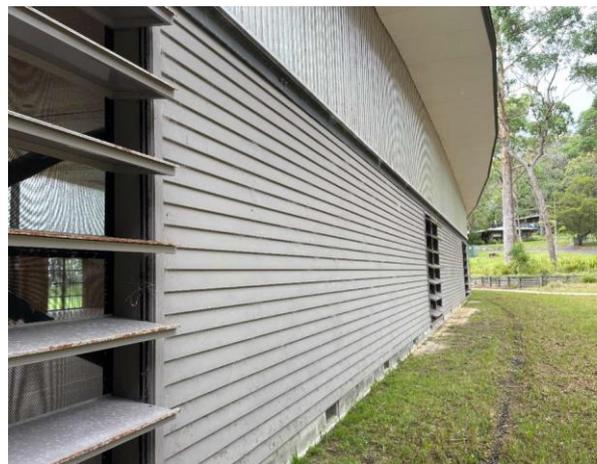
Line ID 12: External, Recreation Hall, Ground Floor, Walls, Weatherboard Cladding, Compressed Cement Sheetting - No Asbestos Detected

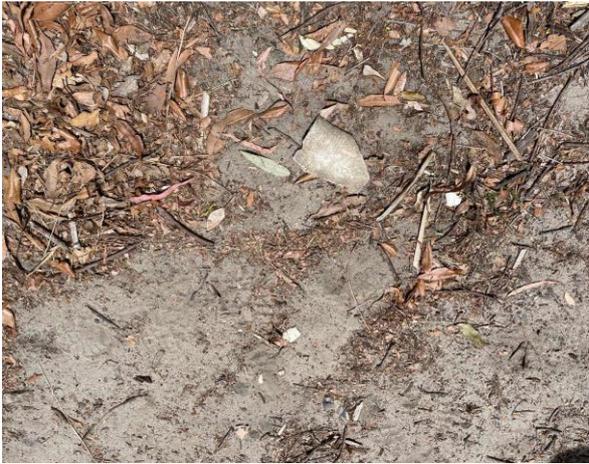
Line ID 13: External, Rotunda Canopy, Ground Floor, Debris to Soil Adjacent Rotunda Canopy, Moulded Fibre Cement Debris - Chrysotile Asbestos Detected

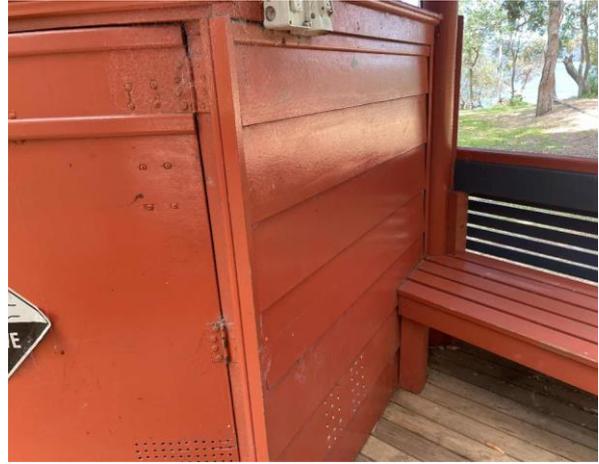
Line ID 14: External, Rotunda Canopy, Ground Floor, Walls Within Canopy Area, Compressed Cement Sheeting - No Asbestos Detected

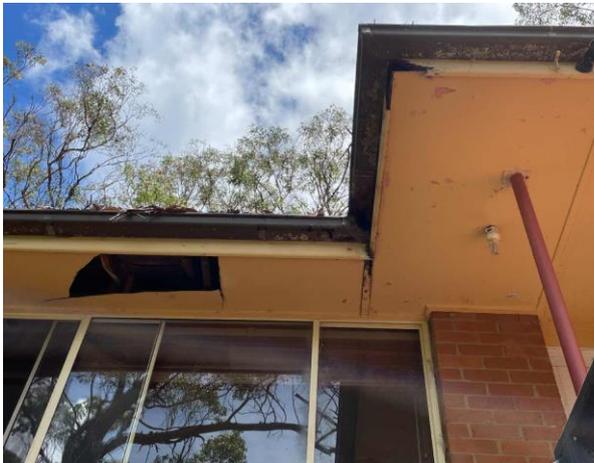
Line ID 15: External, Stone Lodge, Ground Floor, Eaves to Western Building, Fibre Cement Sheeting - Suspected Asbestos

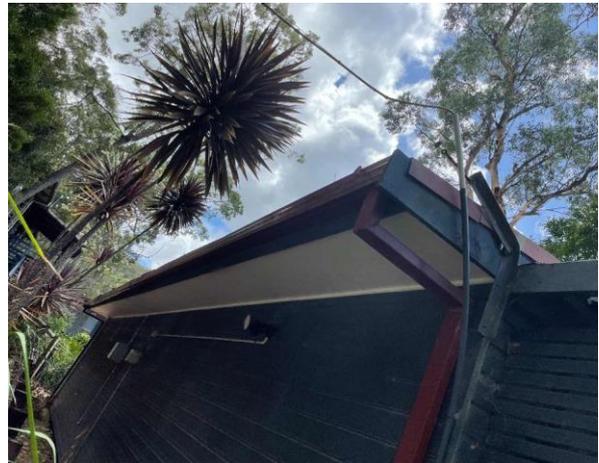
Line ID 16: External, Visiting Teachers Residence, Ground Floor, Eaves, Fibre Cement Sheeting - Suspected Asbestos

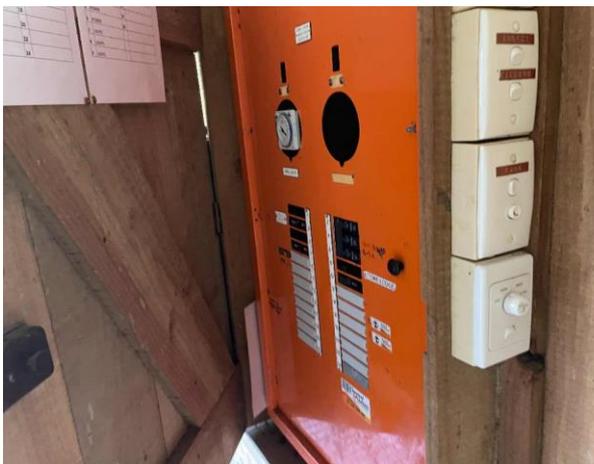
Line ID 17: Internal, Accommodation Lodges, Ground Floor, Within Wall Mounted Switchboard Cupboards, HRC Fuses - Suspected Asbestos

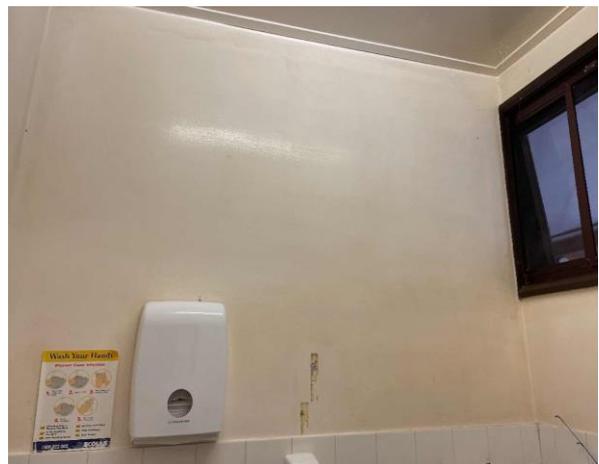
Line ID 18: Internal, Dining Hall, Ground Floor, Laundry Room, Wall Lining, Fibre Cement Sheeting - Chrysotile Asbestos Detected

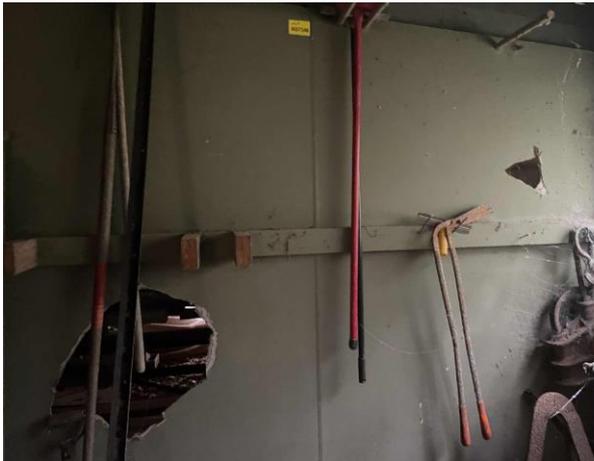
Line ID 19: Internal, Maintenance Shed, Ground Floor, Dividing Wall, Fibre Cement Sheet - No Asbestos Detected

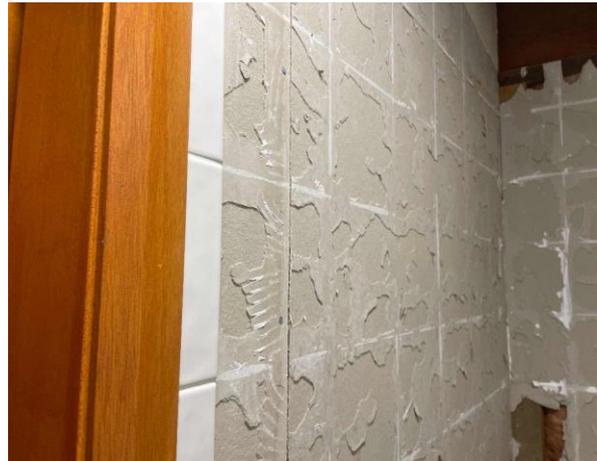
Line ID 20: Internal, Manager on Call House, Ground Floor, Ensuite Bathroom, Behind Ceramic Tiles, Compressed Cement Sheetting - No Asbestos Detected

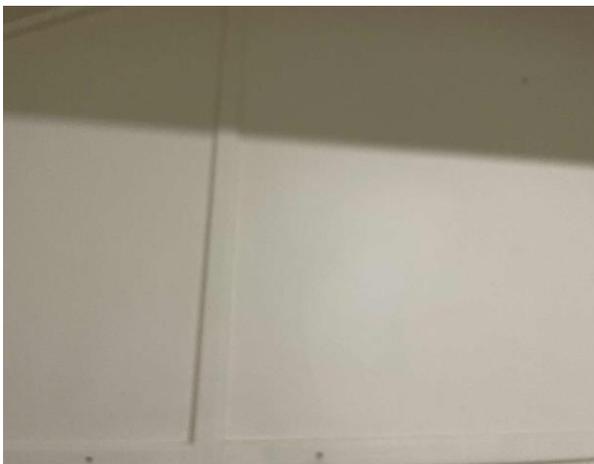
Line ID 21: Internal, Manager on Call House, Ground Floor, Northern Room, Wall and Ceiling Lining, Fibre Cement Sheetting - No Asbestos Detected

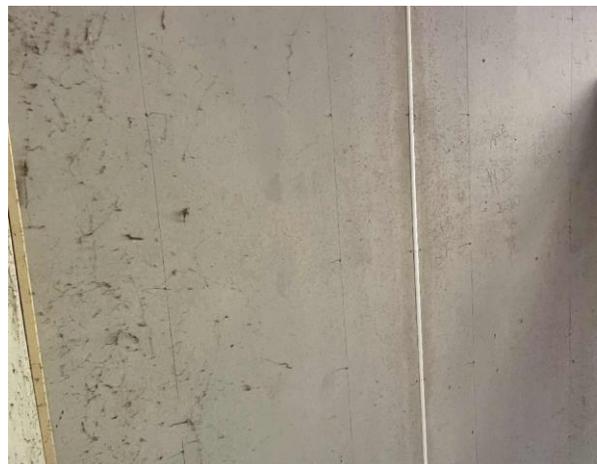
Line ID 22: Internal, Manager on Call House, Ground Floor, South-East Subfloor, Wall Lining, Fibre Cement Sheetting - No Asbestos Detected

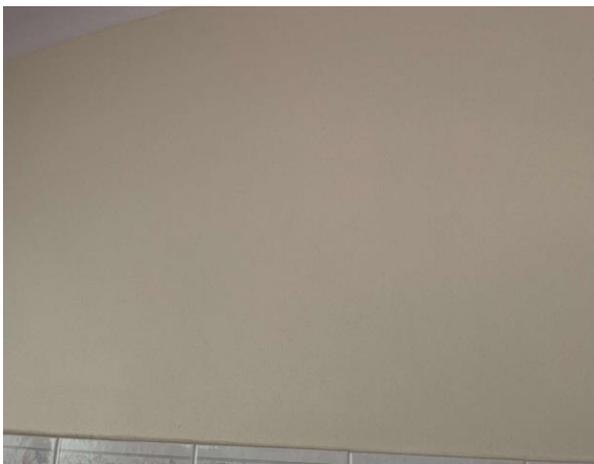
Line ID 23: Internal, Manager on Call House, Level One, Bathroom and Toilet, Wall Lining and Behind Ceramic Wall Tiles, Fibre Cement Sheetting - No Asbestos Detected

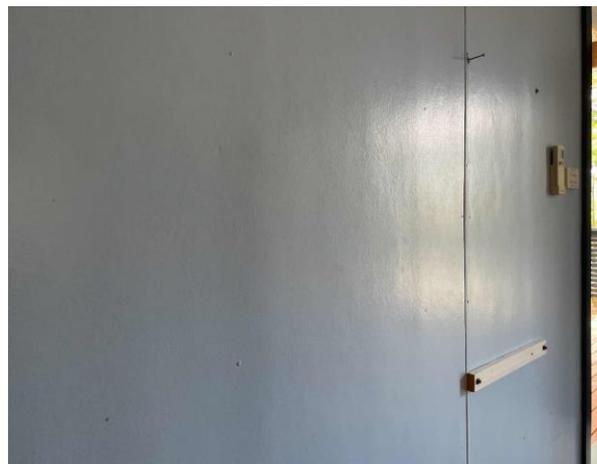
Line ID 24: Internal, Meeting Room, Ground Floor, Aboriginal Museum, Wall Lining, Fibre Cement Sheetting - No Asbestos Detected

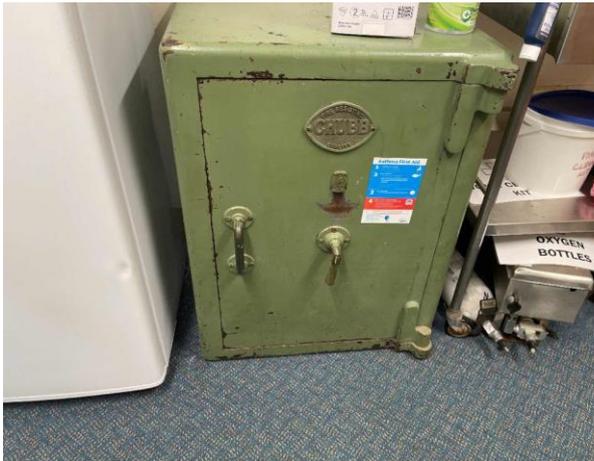
Line ID 25: Internal, Office Building, Ground Floor, First Aid Room, Rope Insulation to Safe, Woven Material - Suspected Asbestos

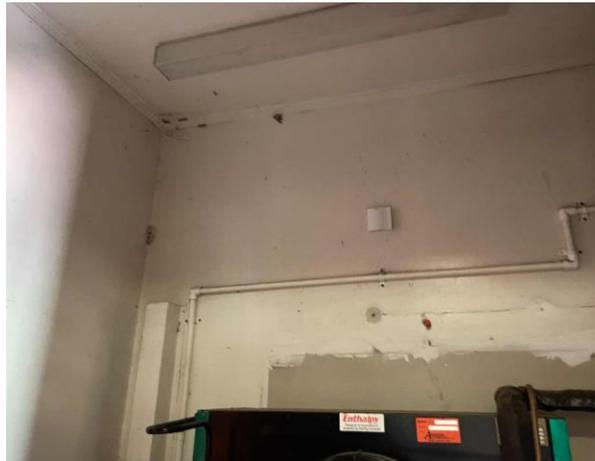
Internal	Office Building / Ground Floor / Plant Room, Wall Lining	Fibre Cement Sheeting	Asbestos	A24254.1	Chrysotile Asbestos Detected	Non-Friable	5 m ²	Low	5 Yearly Reinspection	Maintain in current condition if to remain in-situ. Remove under controlled non-friable asbestos removal conditions prior to refurbishment or demolition works by a Class B (non-friable) licensed asbestos removal contractor in accordance with relevant State Regulations, Compliance Codes, Codes of Practice and Guidance Notes.	26
Internal	Pool Area / Ground Floor / Female and Male Bathrooms, Wall Lining and Cubicle Partitions	Compressed Cement Sheeting	Asbestos	A24270	No Asbestos Detected	-	70 m ²	-	-	-	27

Line ID 26: Internal, Office Building, Ground Floor, Plant Room, Wall Lining, Fibre Cement Sheeting - Chrysotile Asbestos Detected

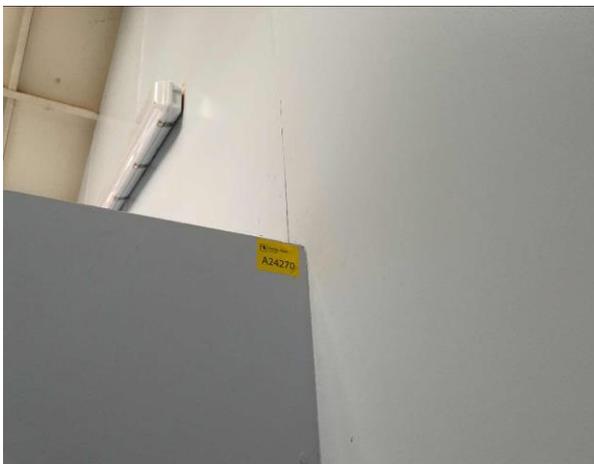
Line ID 27: Internal, Pool Area, Ground Floor, Female and Male Bathrooms, Wall Lining and Cubicle Partitions, Compressed Cement Sheeting - No Asbestos Detected

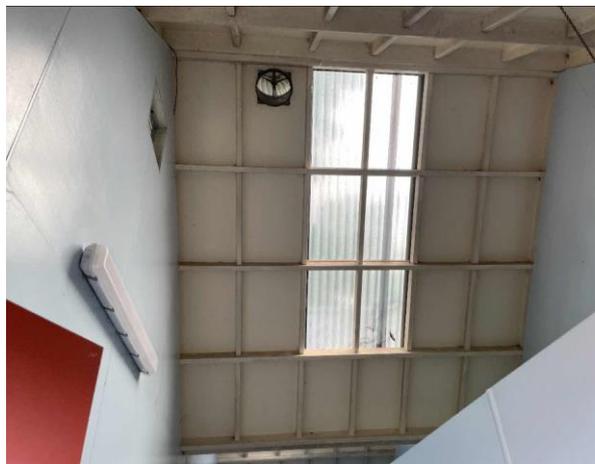
Line ID 28: Internal, Pool Area, Ground Floor, Male and Female Bathrooms, Ceiling Lining, Fibre Cement Sheeting - Suspected Asbestos

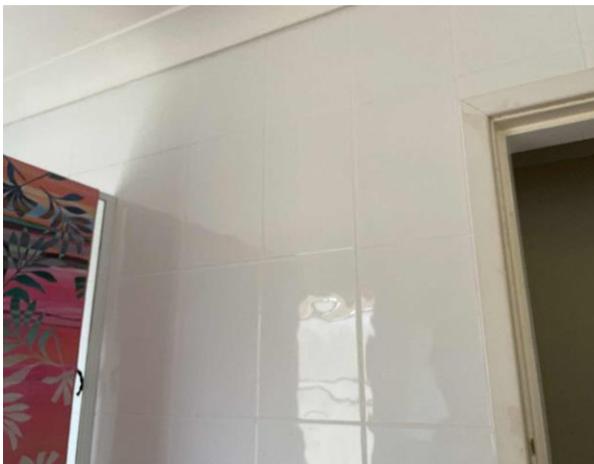
Line ID 29: Internal, Private Residence, Ground Floor, Bathroom, Behind Ceramic Tiles, Fibre Cement Sheeting - Suspected Asbestos

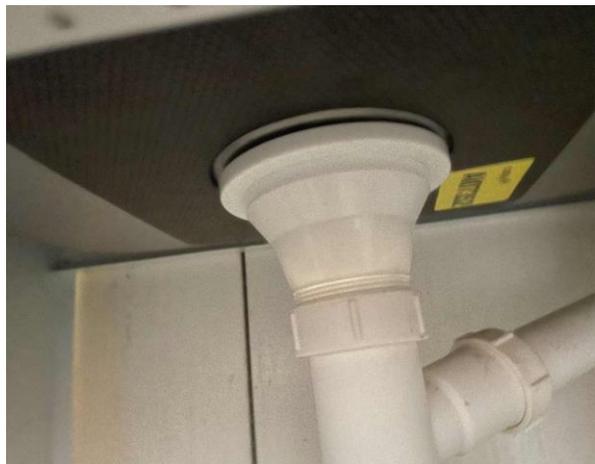
Line ID 30: Internal, Private Residence, Ground Floor, Laundry Room, Under Sink, Sink Pad, Bituminous Membrane - No Asbestos Detected

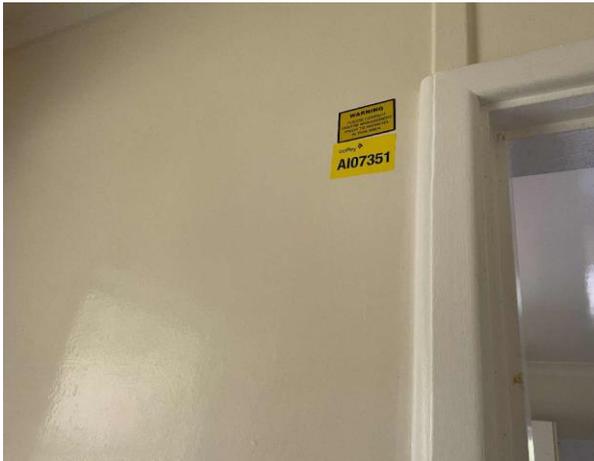
Line ID 31: Internal, Private Residence, Ground Floor, Laundry, Wall Lining, Fibre Cement Sheeting - Chrysotile Asbestos Detected

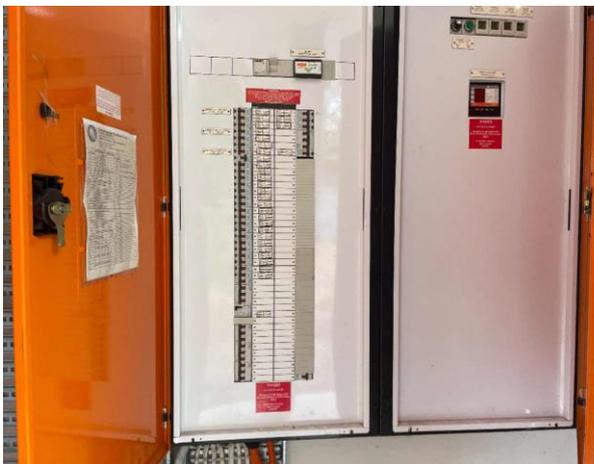
Line ID 33: Internal, Recreation Hall, Ground Floor, Main Switchboard Cupboard, HRC Fuses - Suspected Asbestos

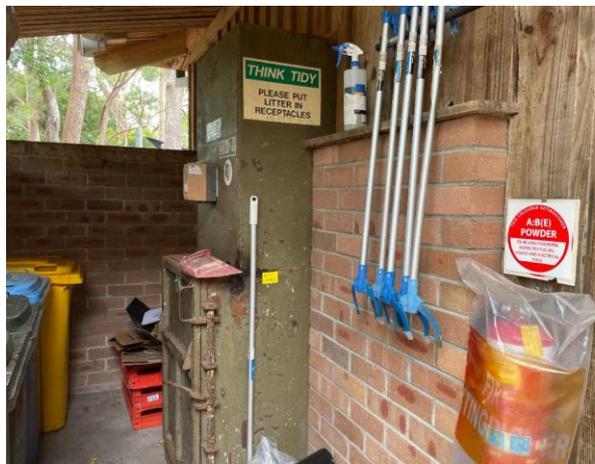
Line ID 34: External, Office Building, Ground Floor, Baler, Green Paint - Lead Detected (0.46% w/w)

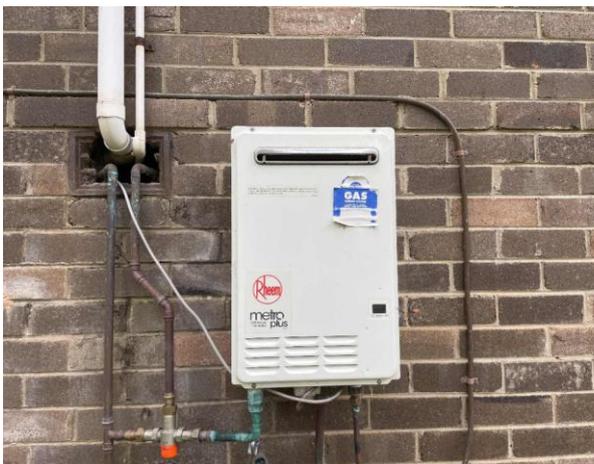
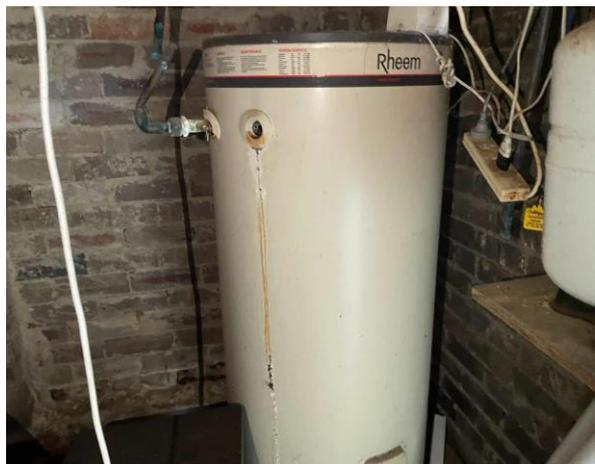
External	Private Residence / Ground Level / North Elevation of Building, Hot Water Heater	Internal Insulation	SMF	754-SYDEN311850 230S4	Suspected SMF	-	2 Units	Very Low	-	Maintain in current condition if to remain in-situ. Remove under controlled SMF conditions as per the Code of Practice for the Safe Use of Synthetic Mineral Fibres [NOHSC: 2006 (1990)].	35

Line ID 35: External, Private Residence, Ground Level, North Elevation of Building, Hot Water Heater, Internal Insulation - Suspected SMF

Line ID 35.1: External, Private Residence, Ground Level, North Elevation of Building, Hot Water Heater, Internal Insulation - Suspected SMF

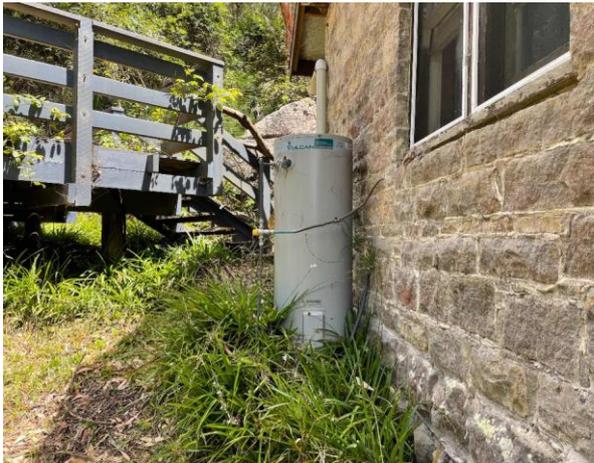
Line ID 36: External, Stone Lodge, Ground Floor, Eastern Building, Hot Water Unit, Internal Insulation - Suspected SMF

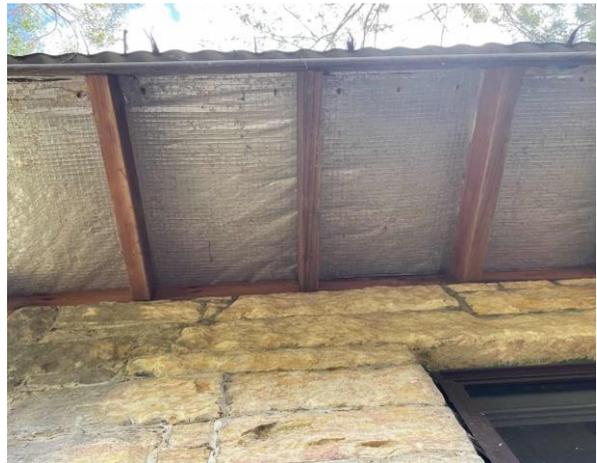
Line ID 37: External, Stone Lodge, Ground Floor, Eastern Building, Underside of Roof, Sarking Insulation - Suspected SMF

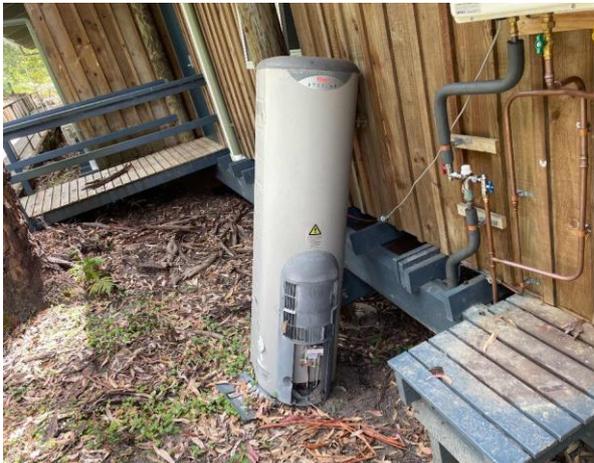
Line ID 38: Internal, Accommodation Lodges, Ground Floor, Lodges, Hot Water Unit, Internal Insulation - Suspected SMF

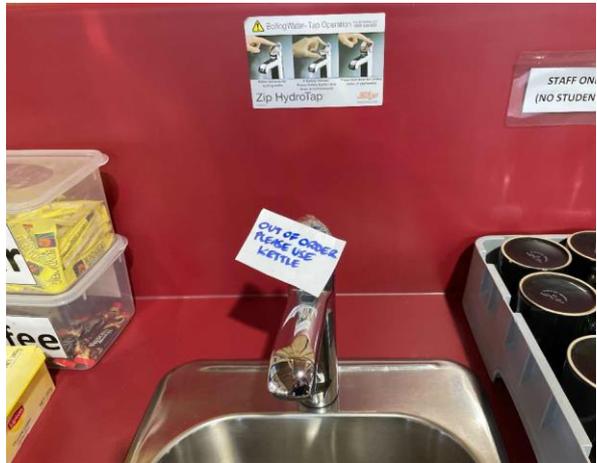
Internal	Dining Hall / Ground Floor / Dining Room, Below Sink, Zip Hydrotap	Internal Insulation	SMF	754-SYDEN311850 230S6	Suspected SMF	-	1 Unit	Very Low	-	Maintain in current condition if to remain in-situ. Remove under controlled SMF conditions as per the Code of Practice for the Safe Use of Synthetic Mineral Fibres [NOHSC: 2006 (1990)].	39
Internal	Manager on Call House / Ground Floor / Ensuite Bathroom, Behind Wall Lining	Insulation Material	SMF	754-SYDEN311850 230S5	Suspected SMF	-	20 m ²	Low	-	Remove under controlled SMF conditions as per the Code of Practice for the Safe Use of Synthetic Mineral Fibres [NOHSC: 2006 (1990)].	40
Internal	Pool Area / Ground Floor / Adjacent Pool, Hot Water Unit	Internal Insulation	SMF	754-SYDEN311850 230S10	Suspected SMF	-	2 Units	Very Low	-	Maintain in current condition if to remain in-situ. Remove under controlled SMF conditions as per the Code of Practice for the Safe Use of Synthetic Mineral Fibres [NOHSC: 2006 (1990)].	41

Line ID 39: Internal, Dining Hall, Ground Floor, Dining Room, Below Sink, Zip Hydrotap, Internal Insulation - Suspected SMF

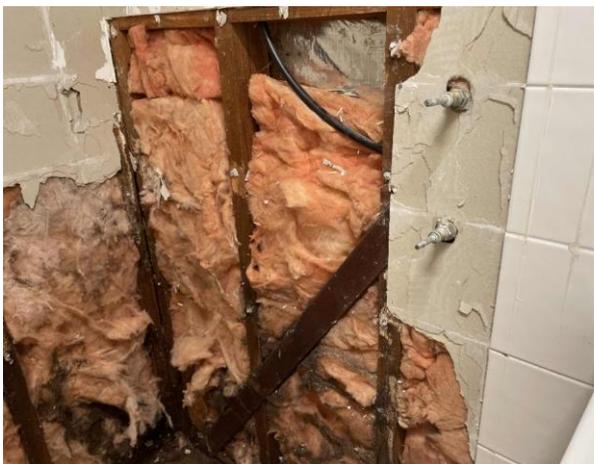
Line ID 40: Internal, Manager on Call House, Ground Floor, Ensuite Bathroom, Behind Wall Lining, Insulation Material - Suspected SMF

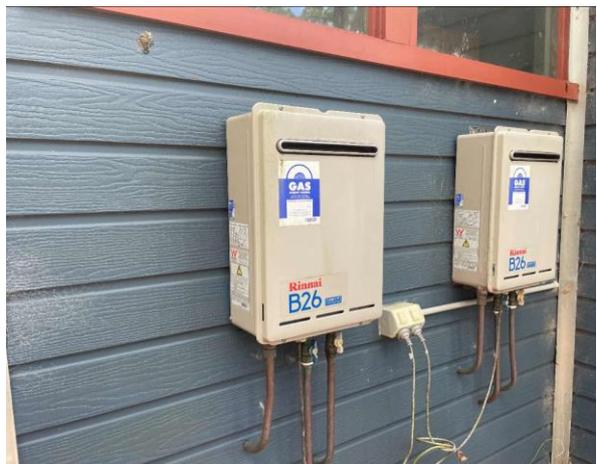
Line ID 41: Internal, Pool Area, Ground Floor, Adjacent Pool, Hot Water Unit, Internal Insulation - Suspected SMF

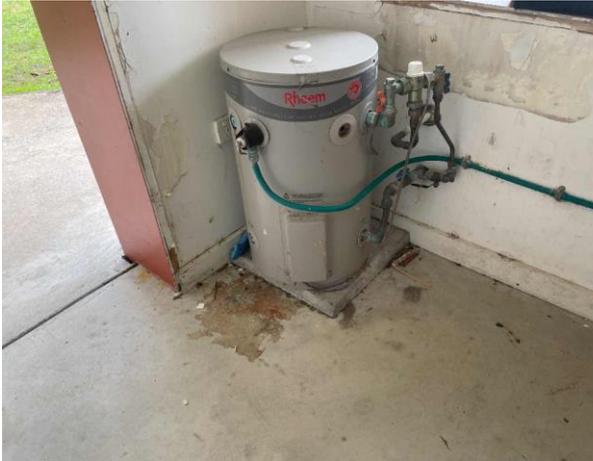
Line ID 42: Internal, Recreation Hall, Ground Floor, Tap Room, Hot Water Heater, Internal Insulation - Suspected SMF

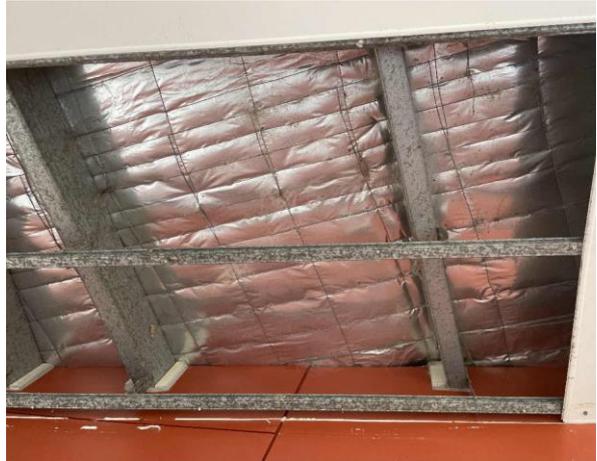
Line ID 43: Internal, Recreation Hall, Ground Floor, Underside of Roof, Sarking Insulation - Suspected SMF

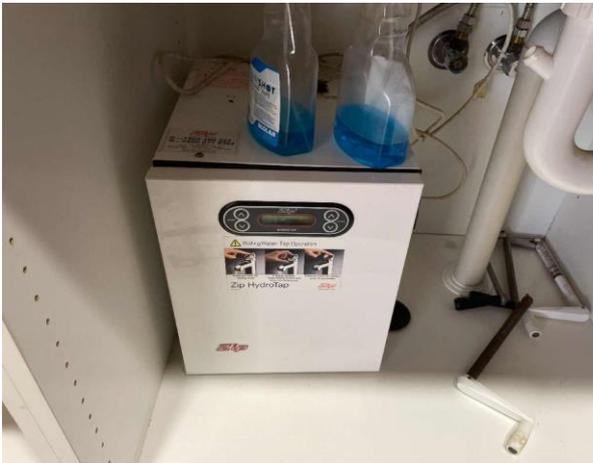
Line ID 44: Internal, Recreation Hall, Ground Floor, Within Kitchen/Storeroom, Zip HydroTap, Internal Insulation - Suspected SMF

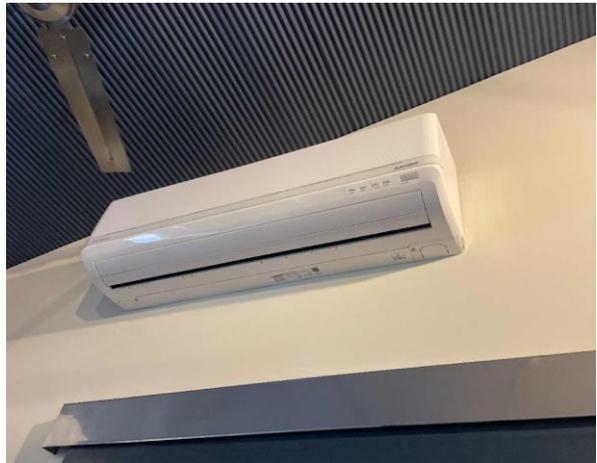
Line ID 45: External, Holiday Units 1-4, Ground Floor, Throughout, Wall Mounted Air Conditioning Unit, R410A Hydrofluorocarbon (HFC) - Non ODS Refrigerant

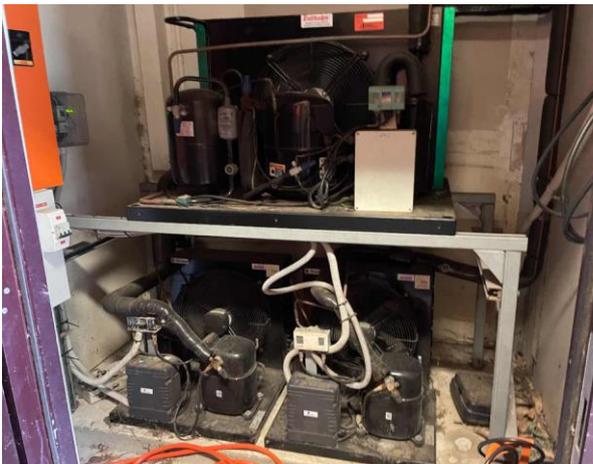
Line ID 46: External, Office Building, Ground Floor, Plant Room, Compressors, R404A Refrigerant - Non ODS Refrigerant

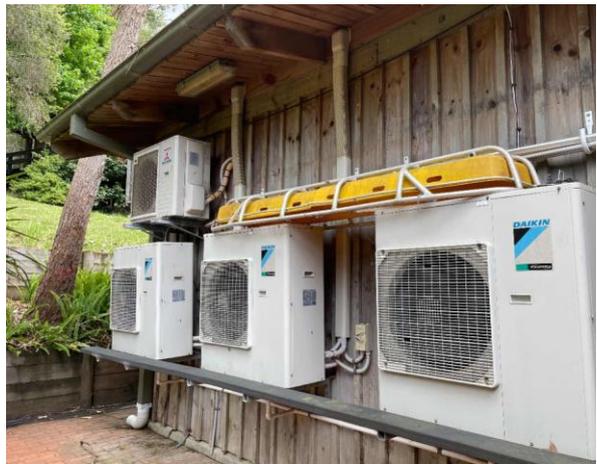
Line ID 47: External, Office Building, Ground Floor, South of Building, Air Conditioning Unit, R410A Hydrofluorocarbon (HFC) - Non ODS Refrigerant

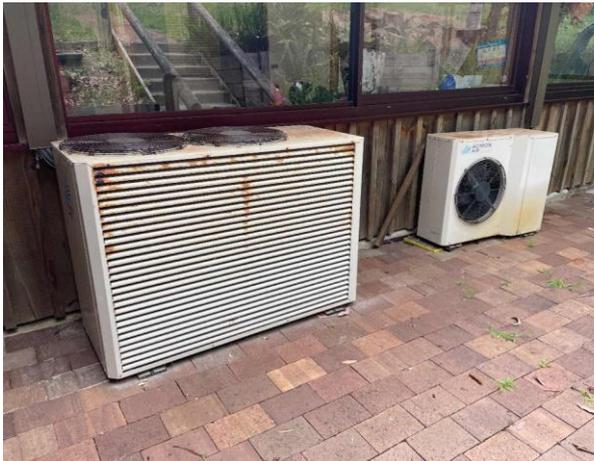
Line ID 48: External, Office Building, Ground Floor, West of Building, Air Conditioning Unit, R22 Hydrochlorofluorocarbon (HCFC) - ODS Refrigerant

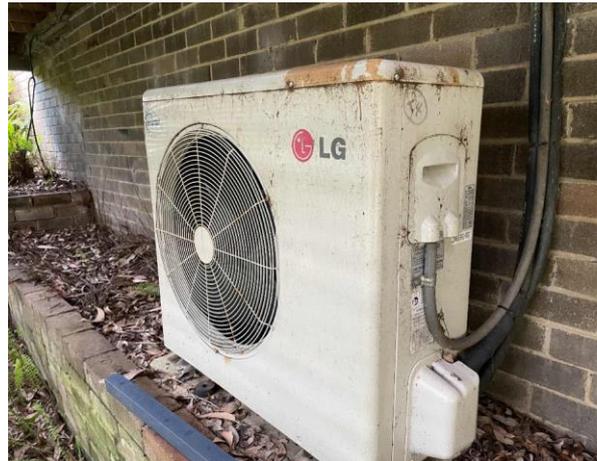
Line ID 49: External, Private Residence, Ground Level, East Elevation of Building, Air Conditioning Unit, R410A Hydrofluorocarbon (HFC) - Non ODS Refrigerant

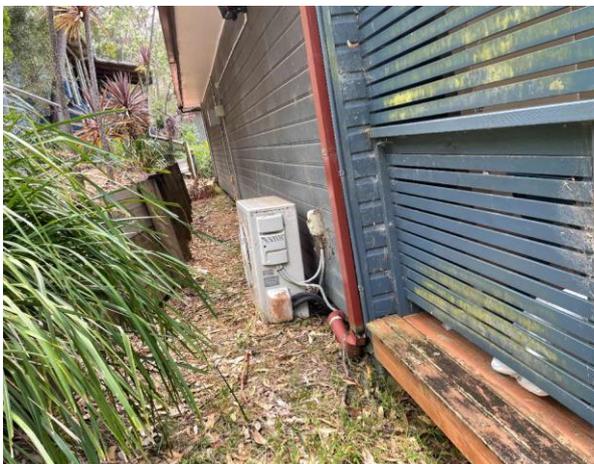
Line ID 50: External, Visiting Teachers Residence, Ground Floor, South Elevation of Building, Air Conditioning Unit, R410A Hydrofluorocarbon (HFC) - Non ODS Refrigerant

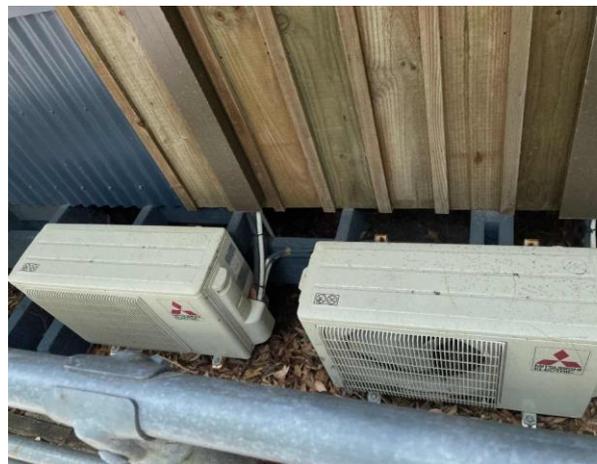
Line ID 51: Internal, Accommodation Lodges, Ground Floor, Lodges, Air Conditioning Unit, Unknown Refrigerant - Suspected ODS

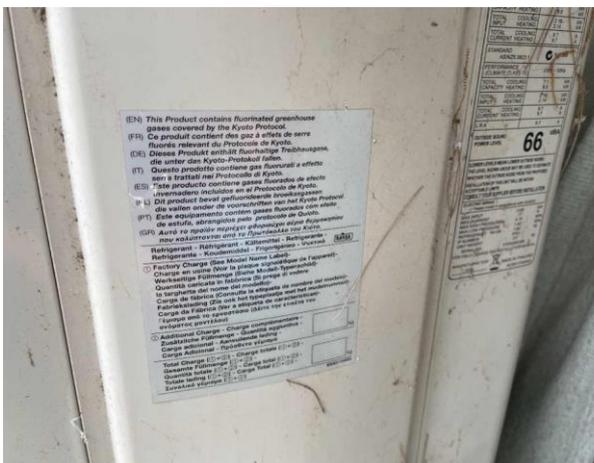
Line ID 52: Internal, Manager on Call House, Ground Floor, Within Various Rooms, Air Conditioning Unit, R410A (HFC) - Non ODS Refrigerant

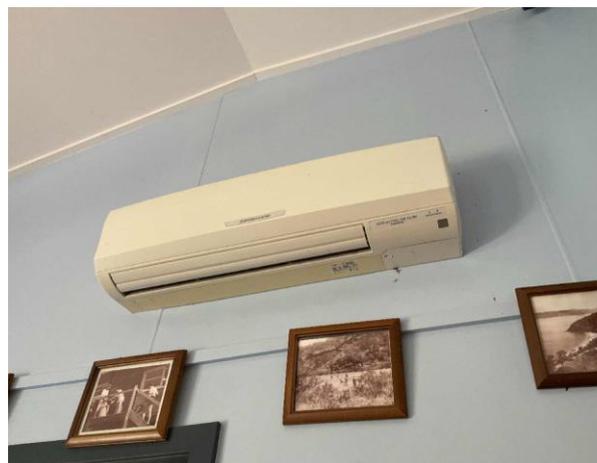
Line ID 53: Internal, Meeting Room, Ground Floor, South Elevation, Air Conditioning Unit, R410A Hydrofluorocarbon (HFC) - Non ODS Refrigerant
